REFUGIO STATE BEACH

GENERAL PLAN

June 1979

Santa Barbara/Ventura Coastal State Park System General Plan

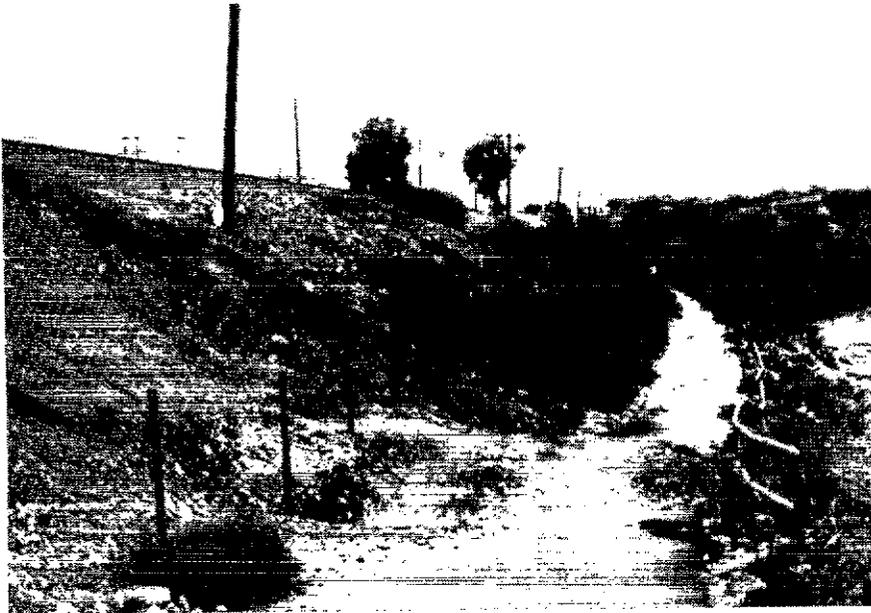
Increased erosion and maintenance costs can be expected where trail setback from the coastal bluff is not adequate. Some of the storm damage to the bicycle trail between Refugio and El Capitan state beaches is shown.

Except for the wide sandy beach around the cove, much of the shoreline at Refugio consists of extremely steep bluffs extending from the marine terraces to the narrow beaches below. In most places, the base material near the narrow beach is Monterey shale or soft, highly fractured lightweight shale. Areas near the beach are capped by various alluvial, terrace, or wind-blown deposits. Most of these areas in the unit are subject to wave action during stormy periods and some are subject to wave action at normal high tides. Occasionally, parts of these terraces slough away, with damage to developments above. Uncontrolled concentrations of runoff may cause deep gullies to form quickly in terraces.

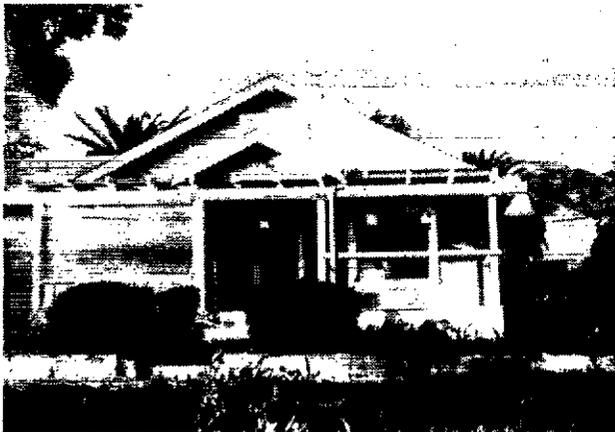
The existing area office will be expanded to house interpretive displays and nature programs.

b) Bottom photograph: replace the caption with the following:
"The area near the existing area office could be developed to house interpretive programs and displays."

4. An interpretive/visitor center building is recommended to be developed to illustrate the significant historic and archeological findings of the area. The existing area office could be expanded and updated to house interpretive programs and displays. It offers ample space for parking. Interpretive panels located on a bluff will illustrate specific historical data for the immediate area and discuss the whale migration visible from the point.

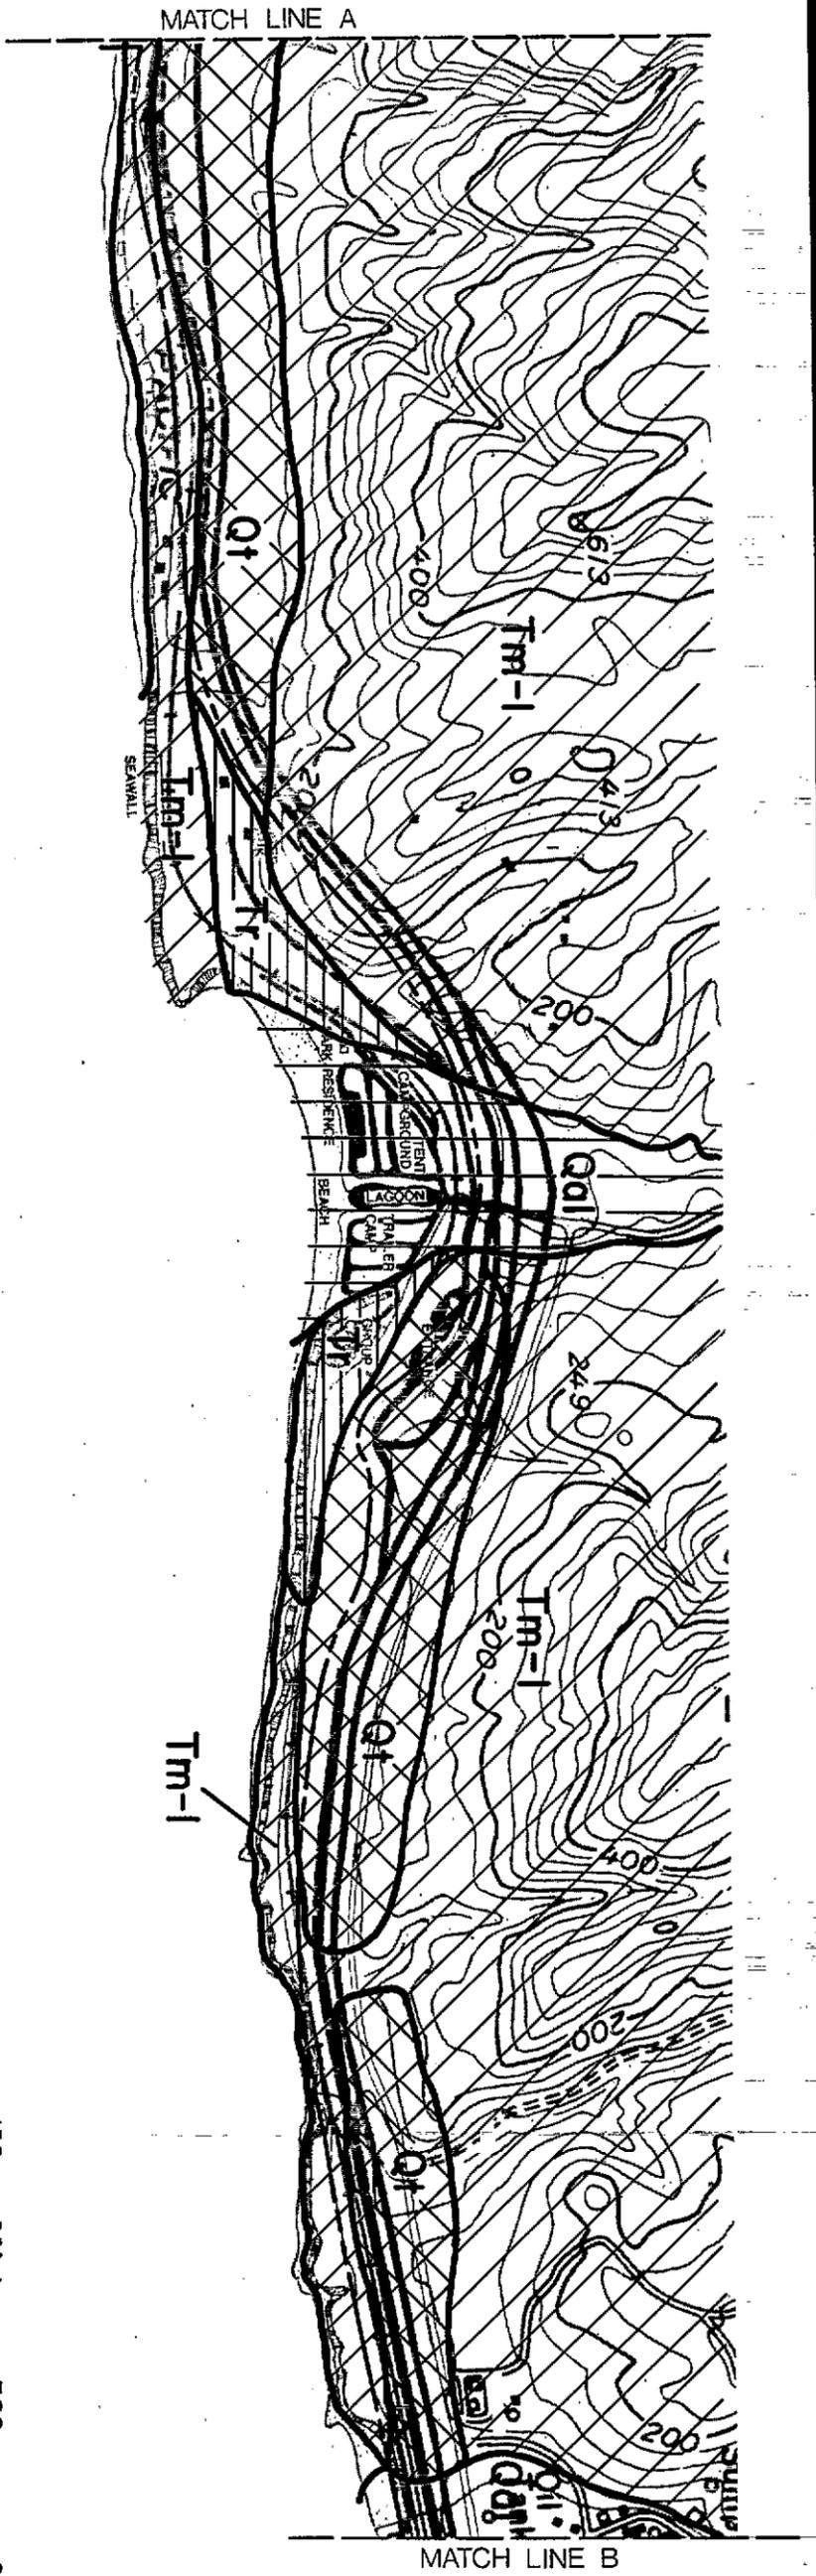
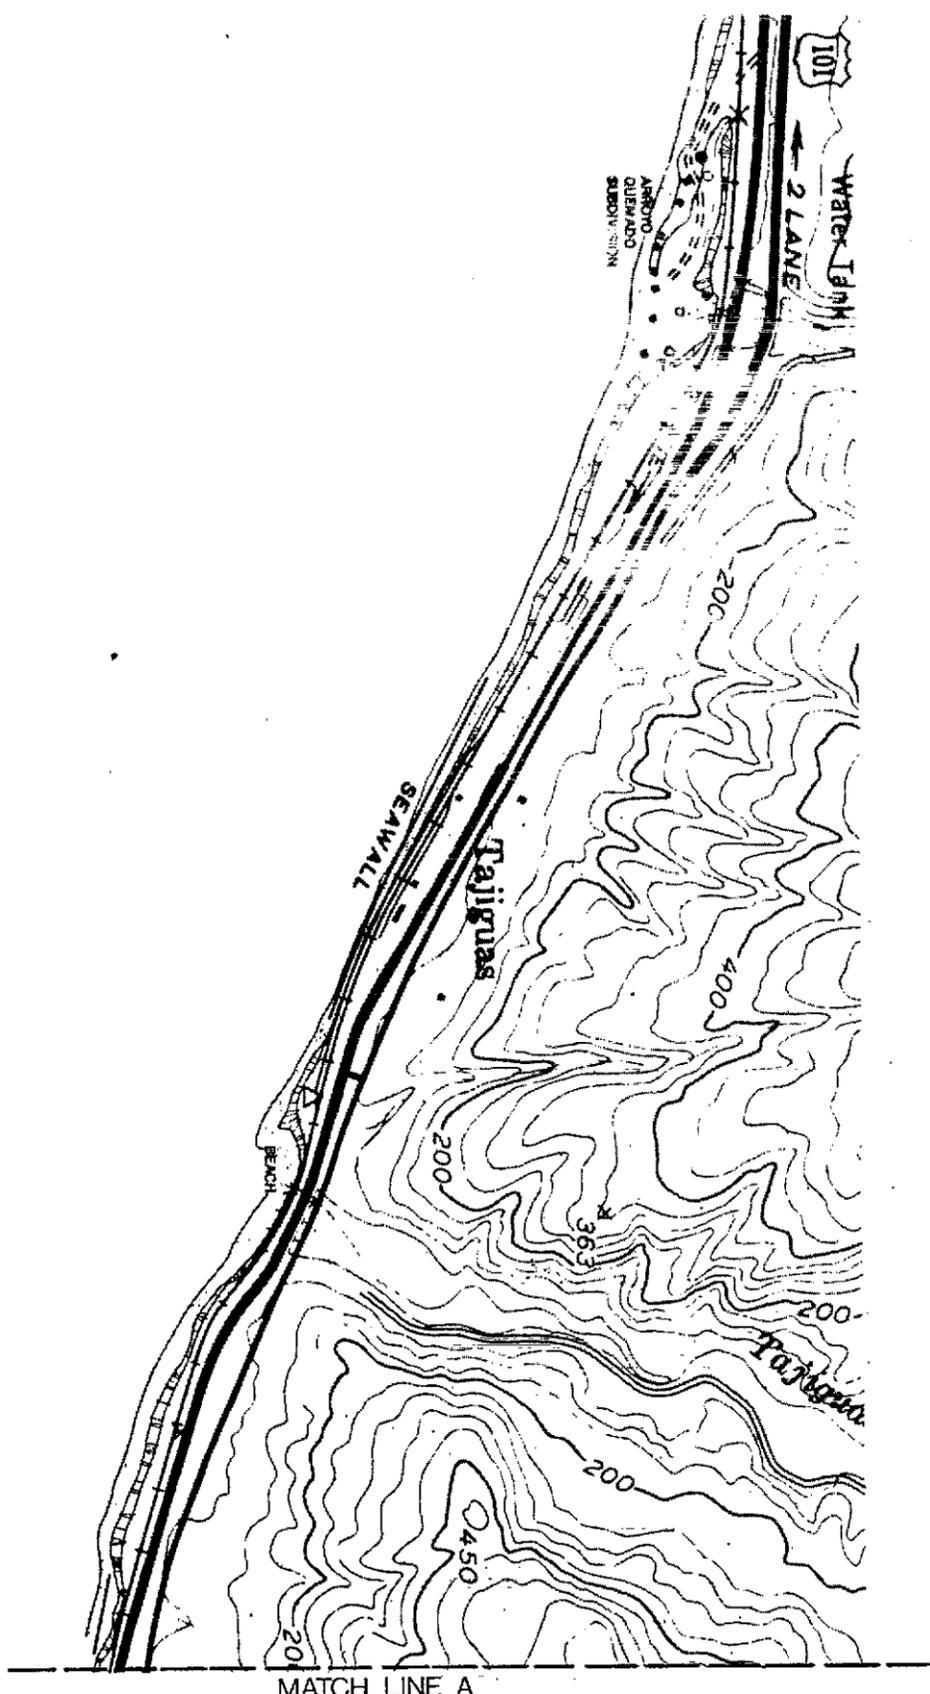
**REFUGIO STATE BEACH
GEOLOGY MAP**

- Alluvium
- Terrace deposits
- Monterey Formation — lower
- Rincon Formation

Source: Dibblee, 1950. Original map scale 1:62,500

The Monterey Formation is characteristically a series of marine deposits of hard, laminated platy shales, softer shales, phosphatic shales, and limestones. The Monterey is also a noted oil-producing formation. Monterey shale is notable for its unusually large amounts of organic debris, composed largely of remains of microscopic plant and animal life. Chitinous remains of fish scales are also abundant throughout the Monterey. Only the lower Monterey Formation is found in Refugio State Beach. This unit is weakly resistant to erosion but more resistant than the underlying Rincon. It, too, tends to fail by sliding. The lower Monterey weathers to a deep, heavy adobe soil which supports only grasses and annual herbs.

Terrace deposits are present along the coast in this area and are Quaternary in age. These deposits typically contain some fossil material; however, no fossils have been found at this unit.

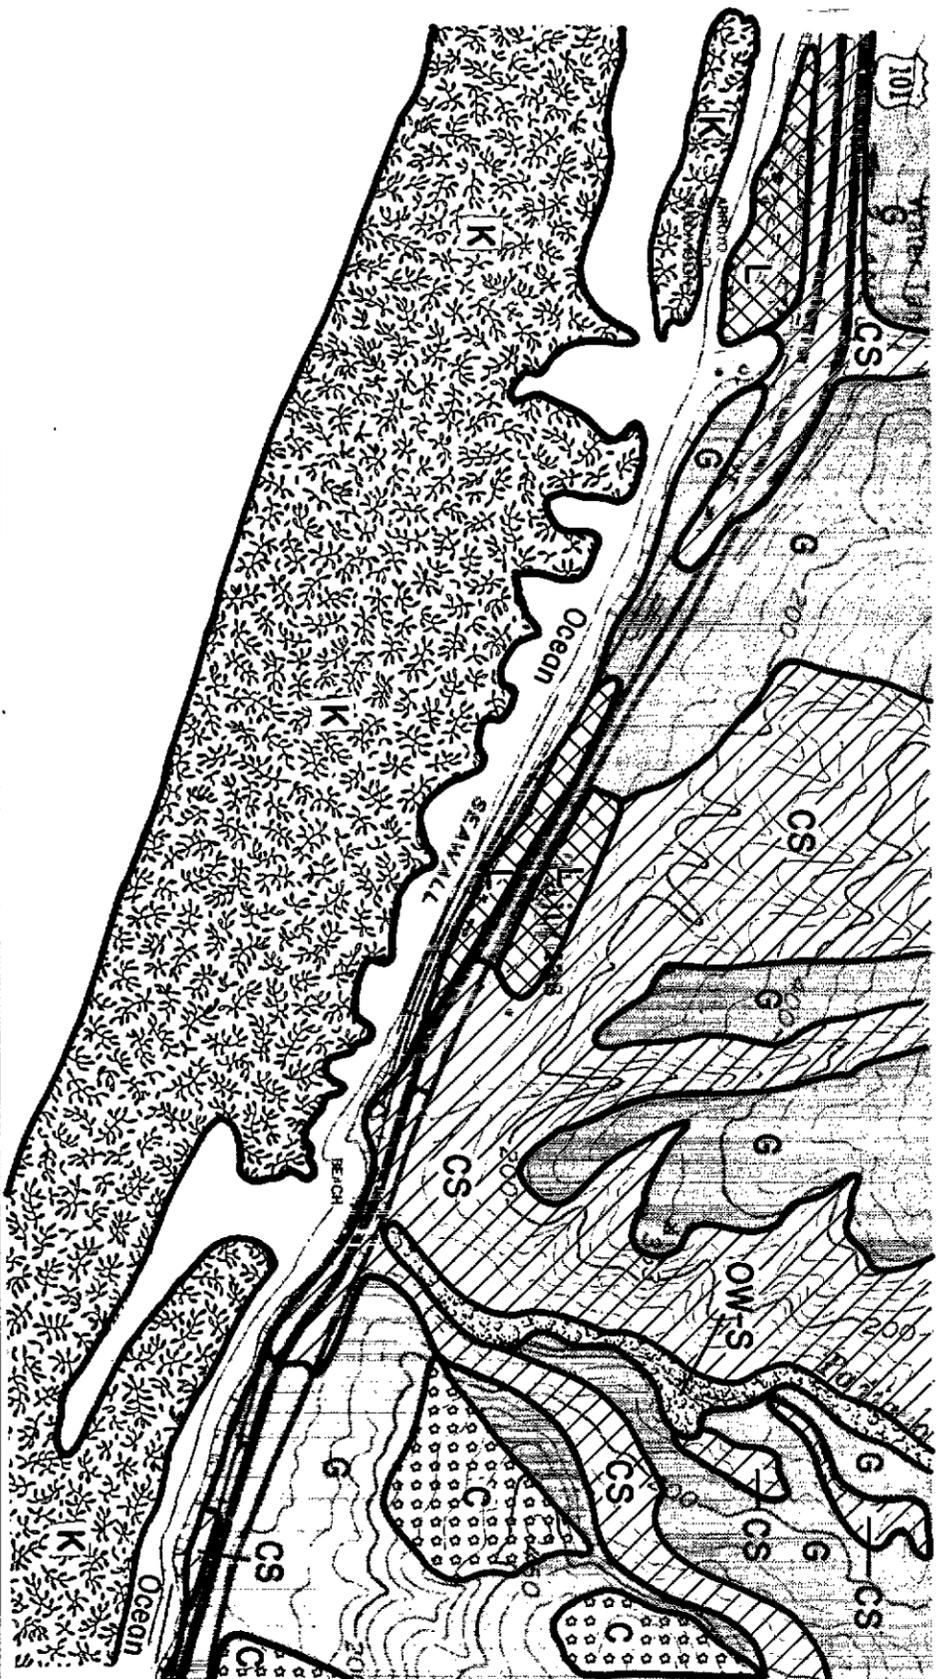
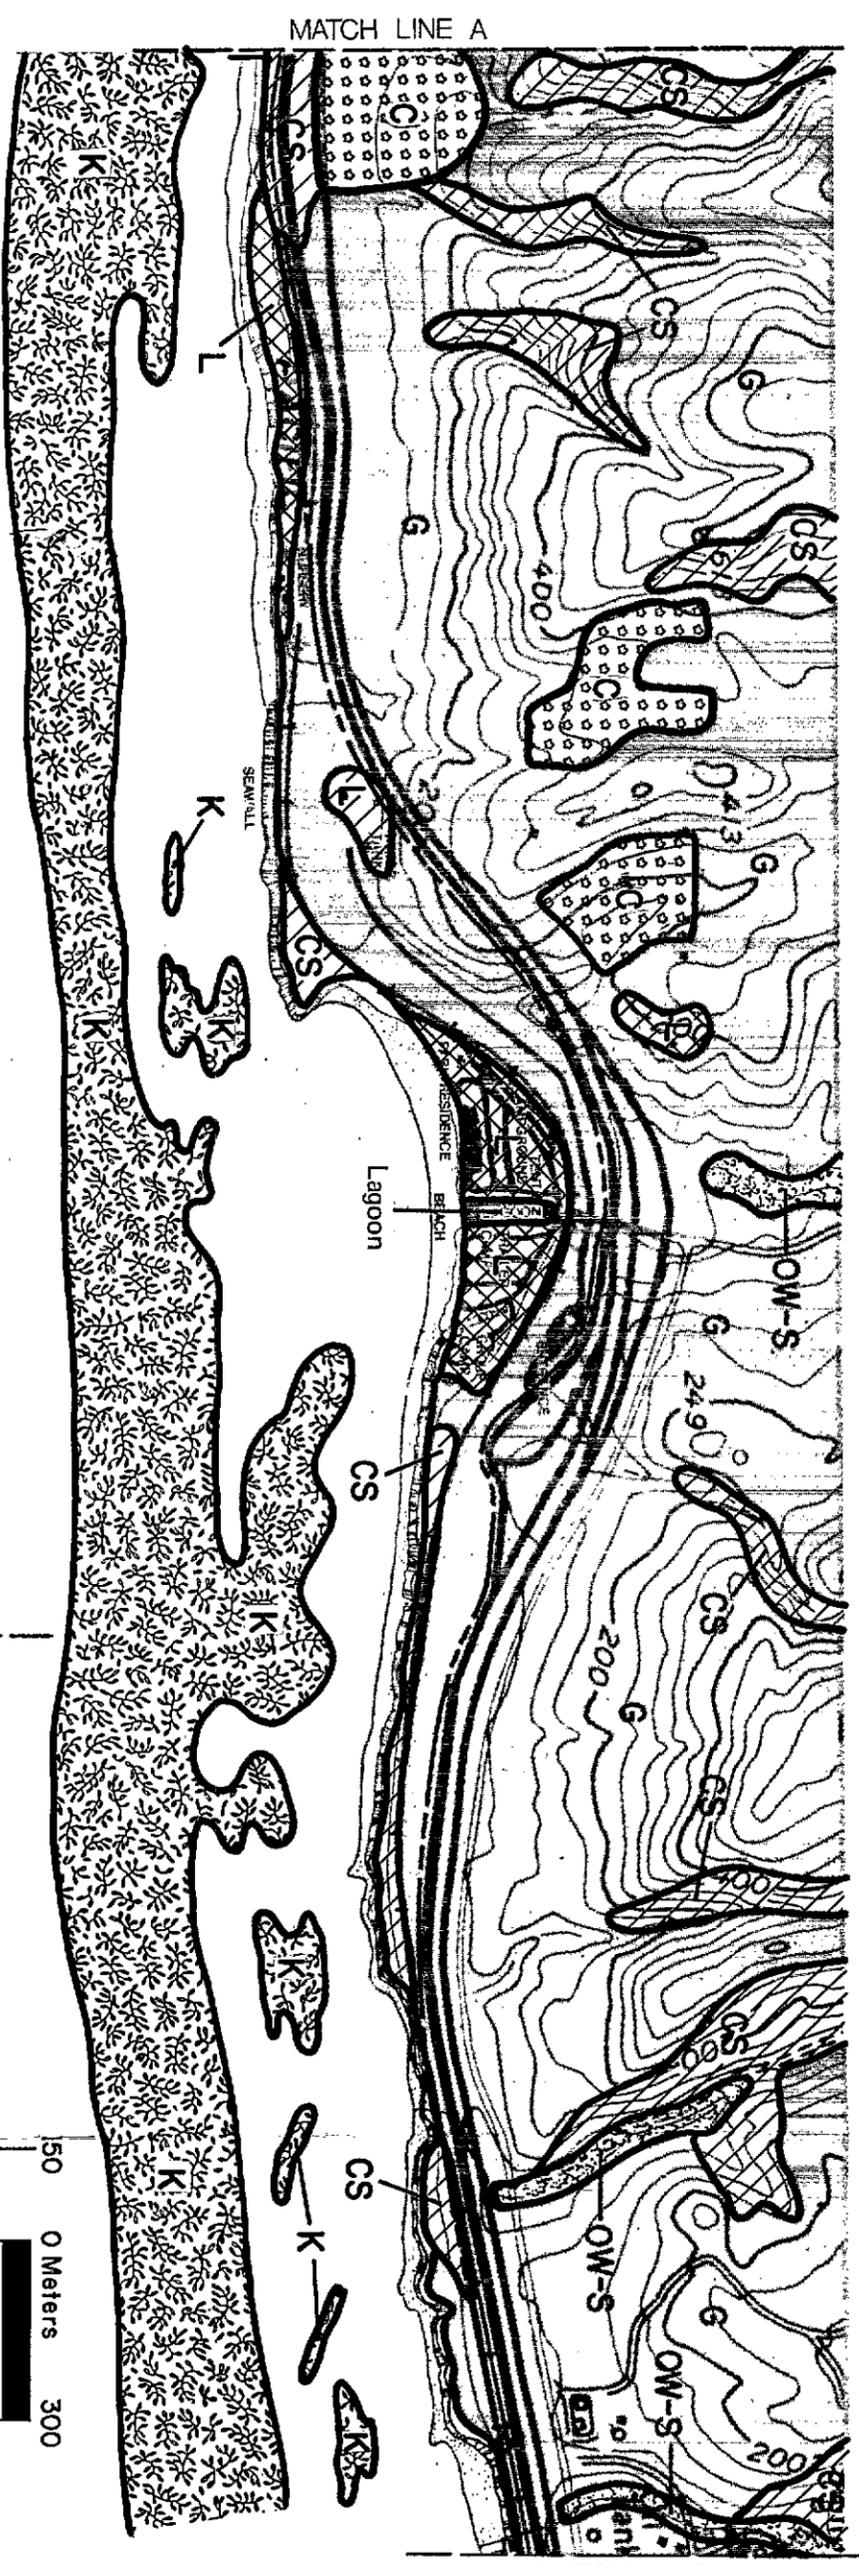
REFUGIO STATE BEACH
VEGETATION MAP

| | Landscaped/habitat areas |
| | Kelp beds |

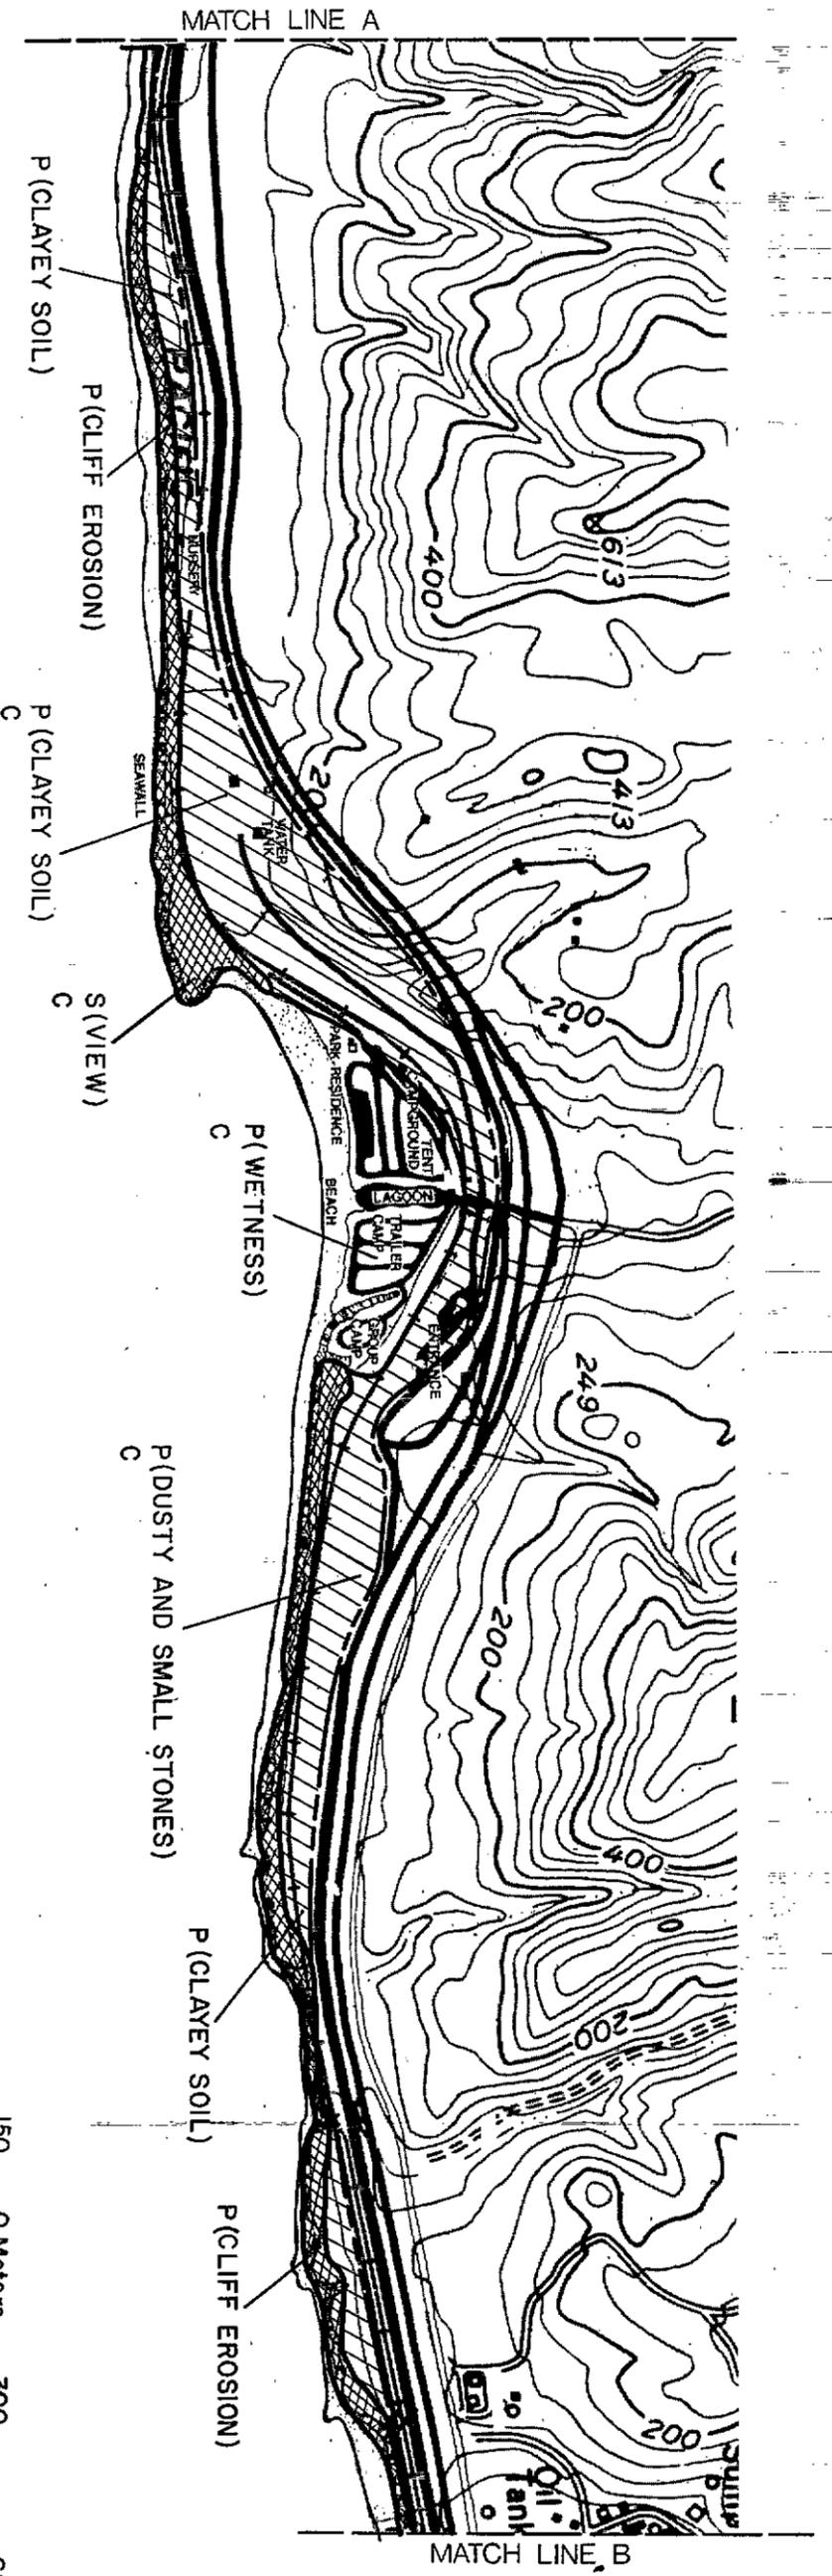
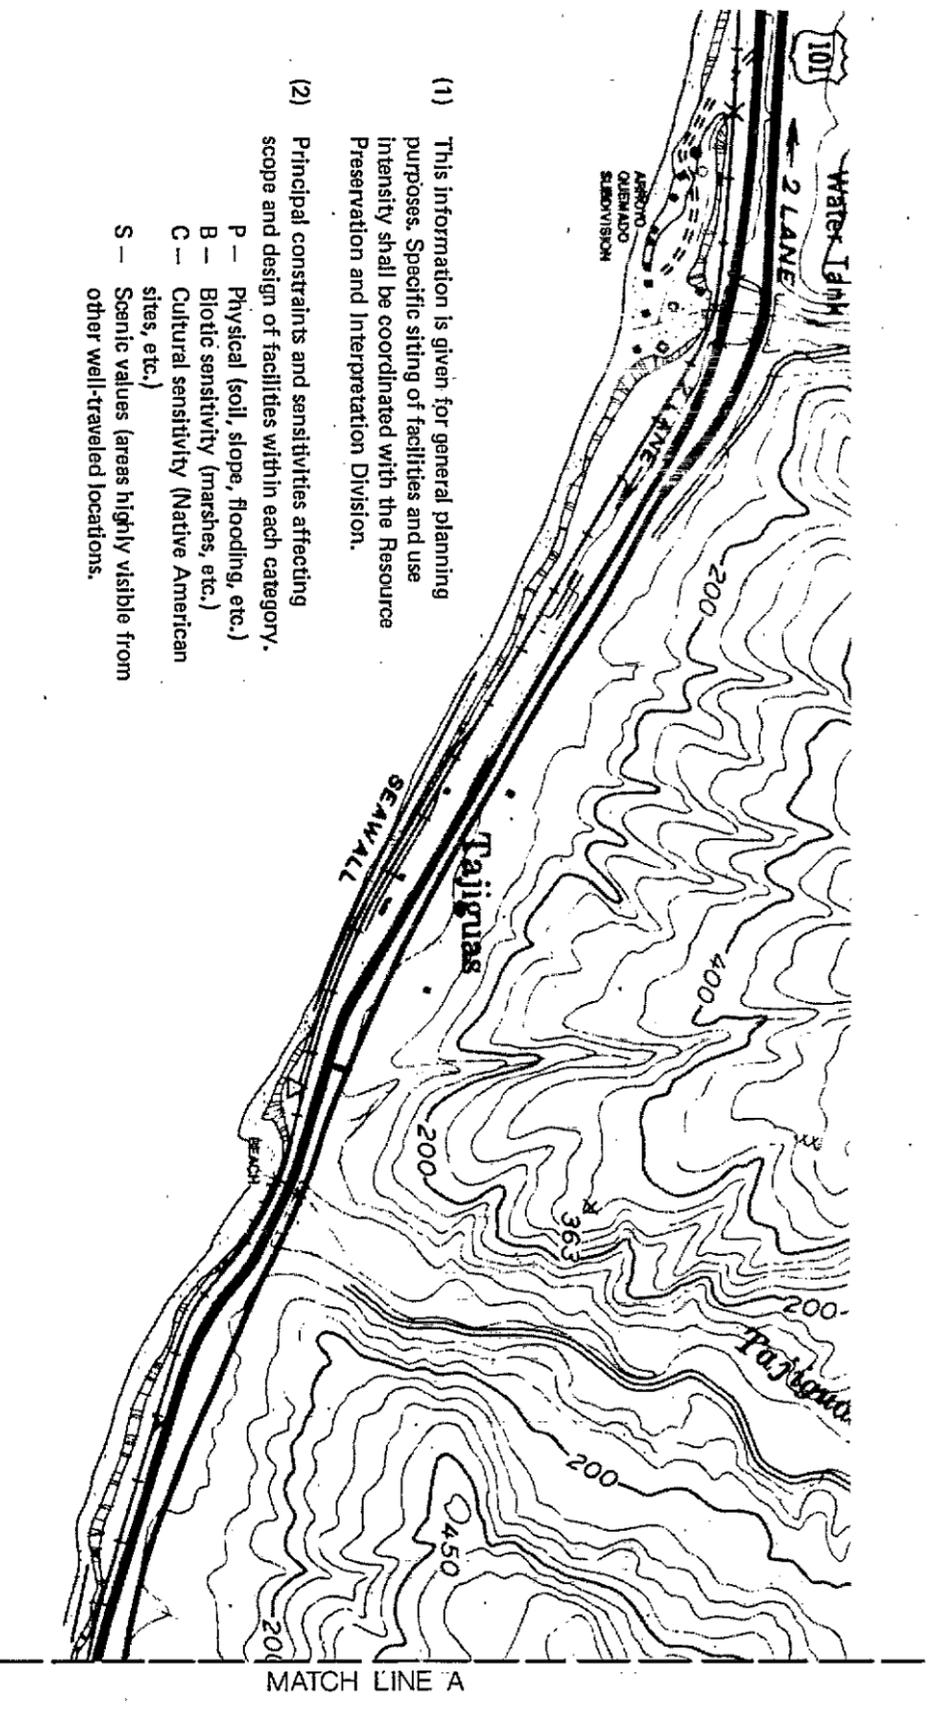
ALLOWABLE USE INTENSITY

- (1) This information is given for general planning purposes. Specific siting of facilities and use intensity shall be coordinated with the Resource Preservation and Interpretation Division.
- (2) Principal constraints and sensitivities affecting scope and design of facilities within each category.
- P - Physical (soil, slope, flooding, etc.)
 - B - Biotic sensitivity (marshes, etc.)
 - C - Cultural sensitivity (Native American sites, etc.)
 - S - Scenic values (areas highly visible from other well-traveled locations).

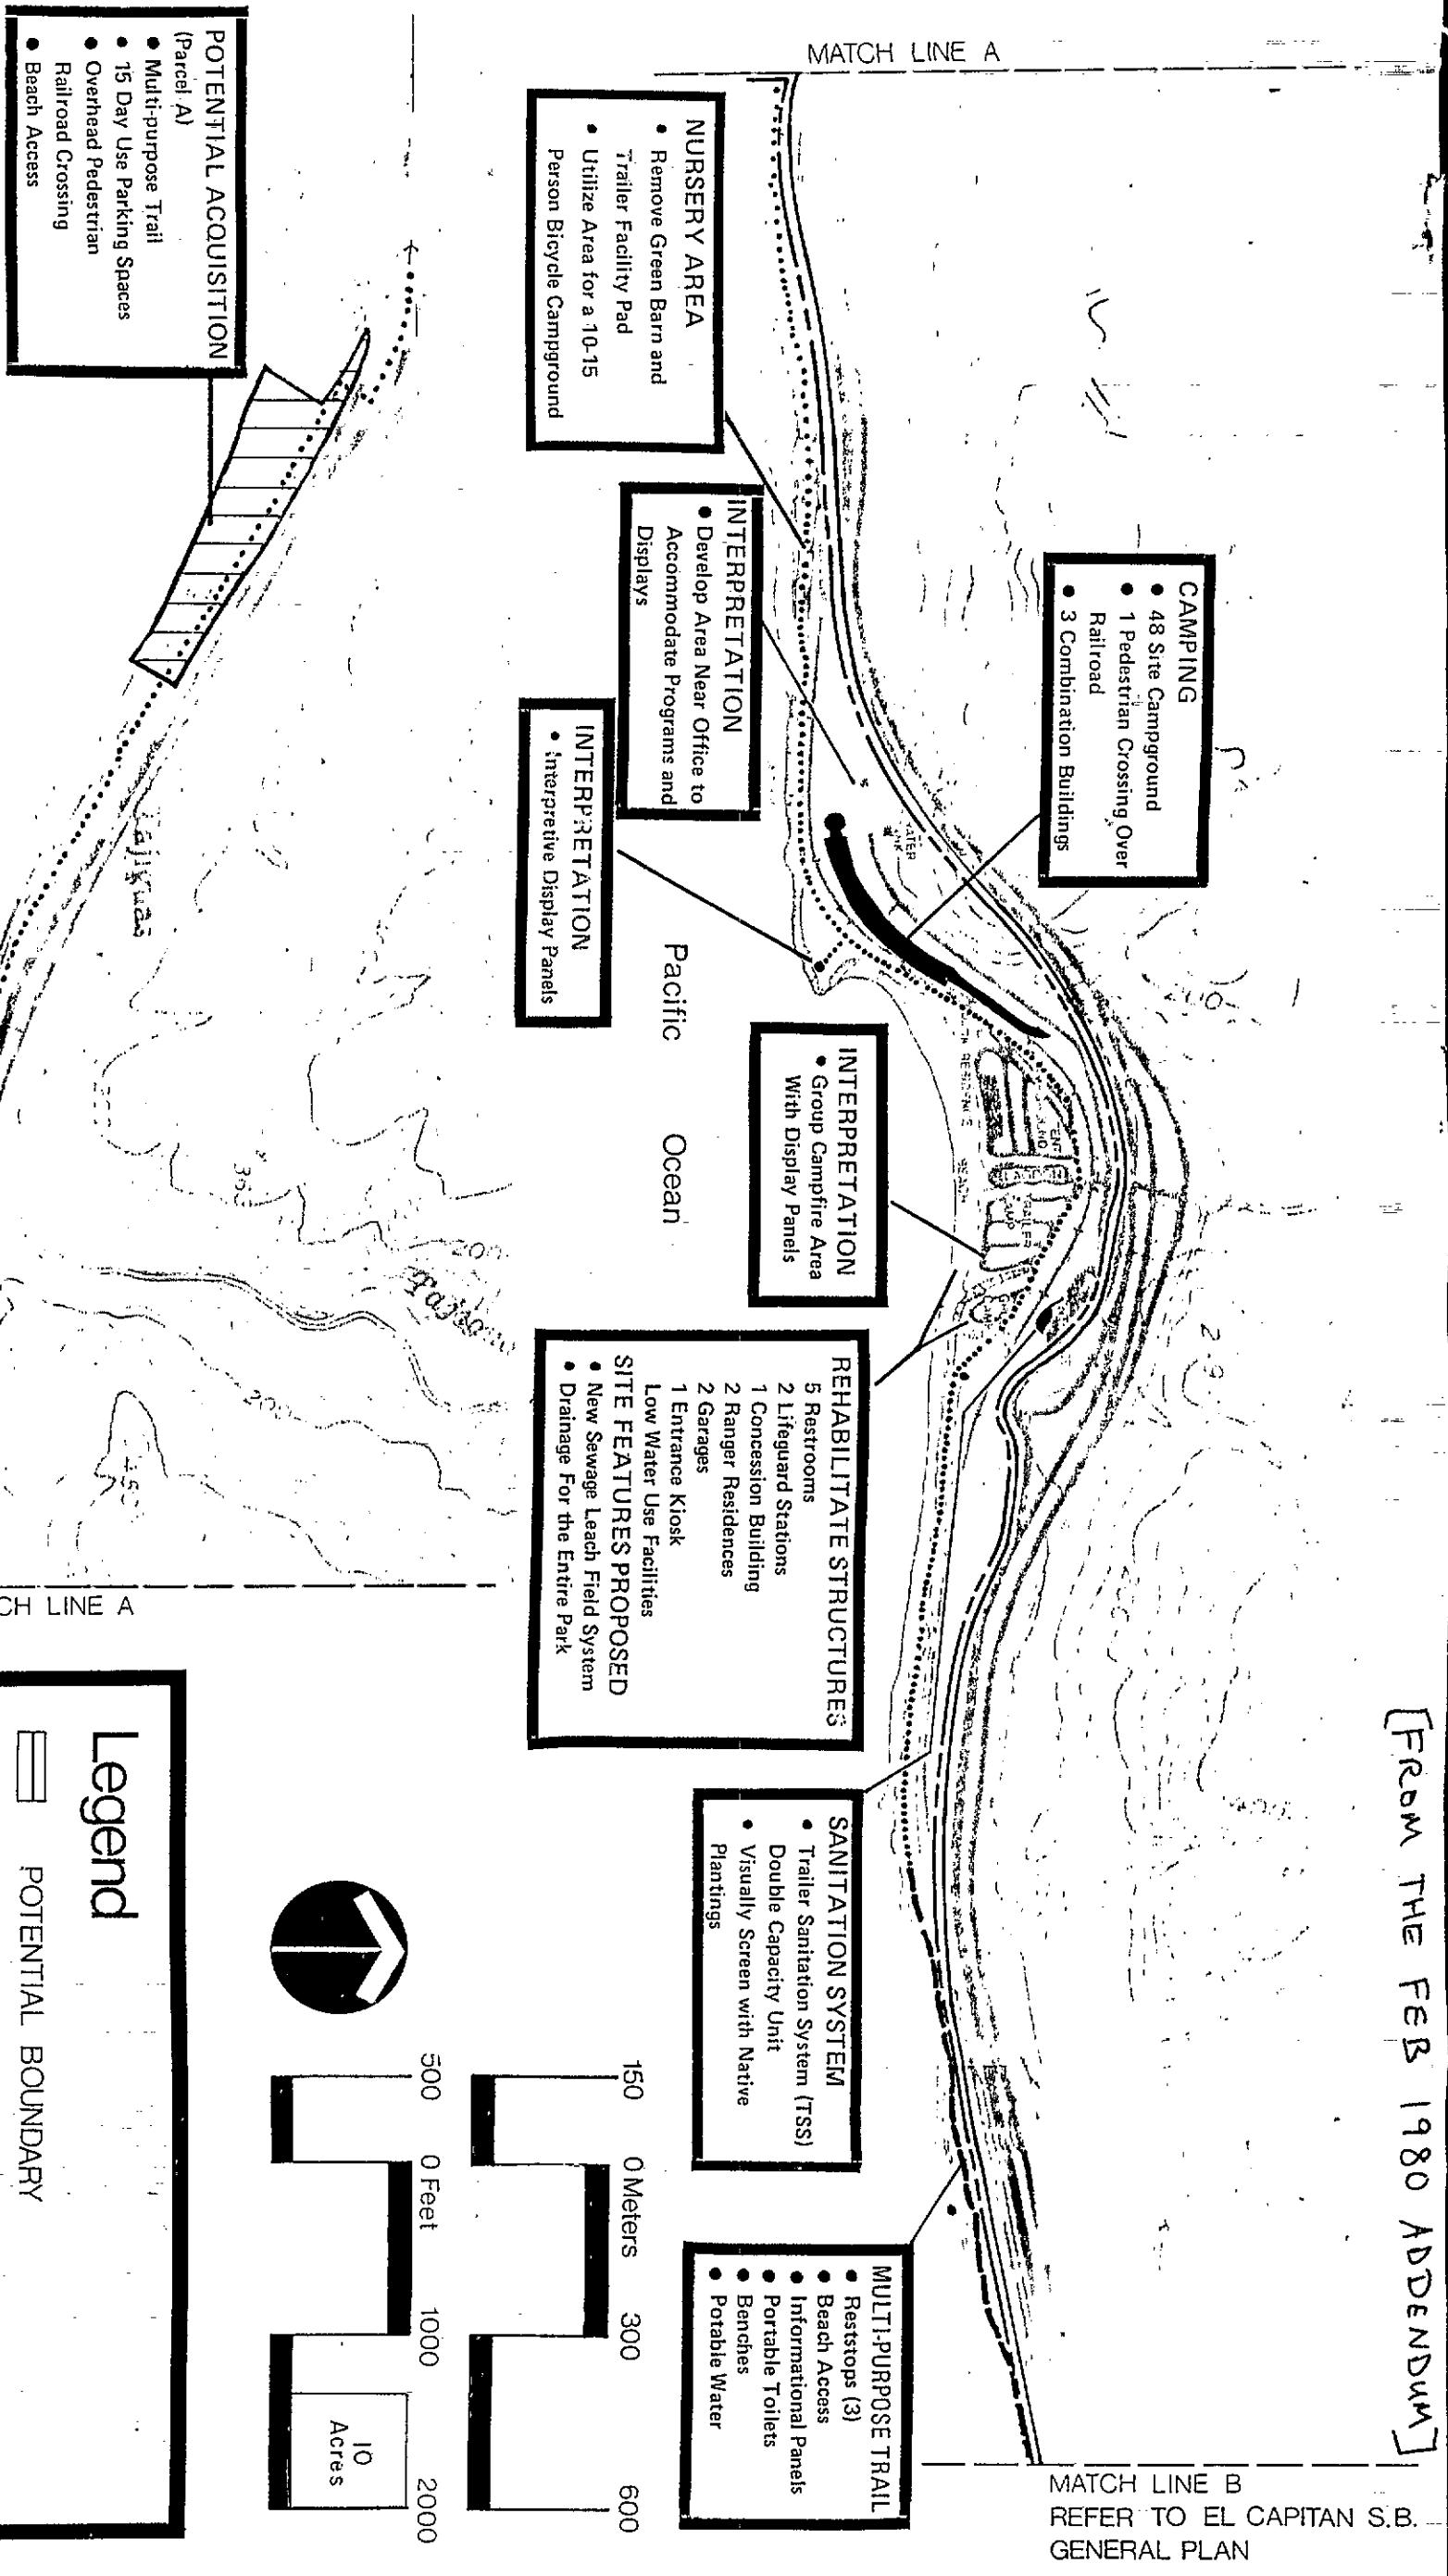
Santa Barbara/Ventura Coastal State Park System Plan
**REFUGIO S.B.
GENERAL PLAN**

POTENTIAL ACQUISITION (Parcel A)

- page 28: Replace chart with attached chart.
- :Plan 4-7: General Plan: replace plan with attached plan.
